ISSUE NO.	VEN2023001
DATE	20/05/2024
COUNTRY	Venezuela

PROBLEM DESCRIPTION(SYMPATOM)

CLIENTE MANIFIESTA VENIA DE CARRETERA ENCENDIO LUZ DE MOTOR Y EMPEZO COMO A TAQUETEAR, Y SE QUEDA / REALIZAR CAMBIO DE ACEITE Y FILTROS

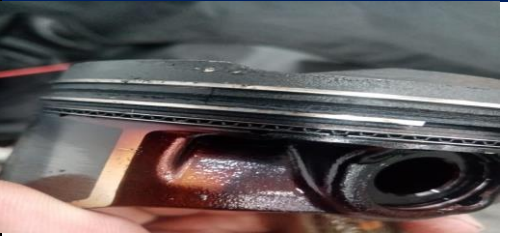
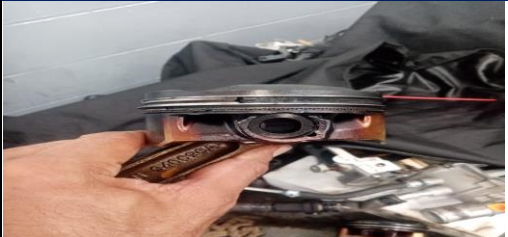
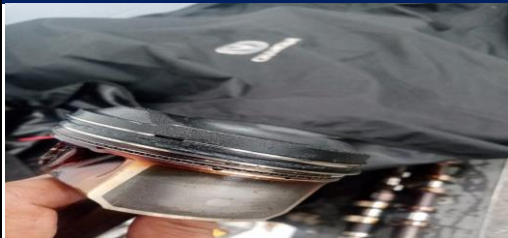
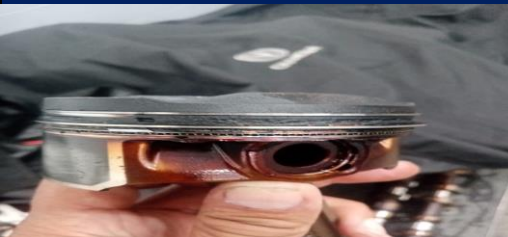
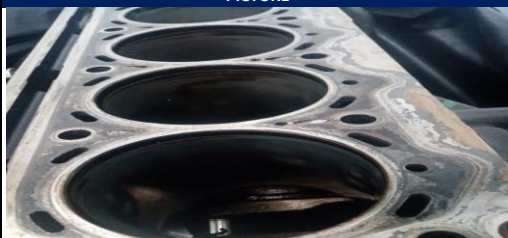
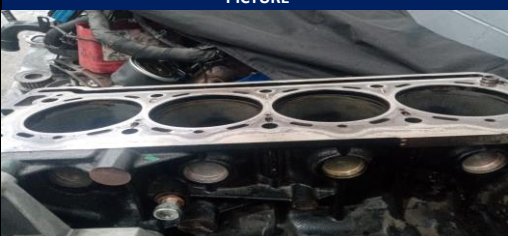
El vehículo presenta inestabilidad al encender perdida de potencia y bajo nivel de aceite en el motor.

Se realizó una inspeccion en el area del motor sin encontrar fuga externa de aceite, se verifica el estado de las bujias y sus valores de resistencia, se evaluan los inyectores ambos se encuentran dentro de lo especificado, se procede a realizar una inspeccion al sistema del turbo cargador notandose una alta presencia de aceite en este sistema de admision, cuerpo de aceleracion, se realiza una prueba de compresion notandose valores de compresion bajos fuera de parametros minimios normales, se procede a desmontaje del motor para realizar evaluacion del mismo, se aprecian 3 pistones fracturados. Por esta razon se sugiere el remplazo del motor.
